SHORELINE CHANGES AT SENDAI PORT DUE TO THE GREAT NORTH EAST JAPAN TSUNAMI OF 2011

Abstract

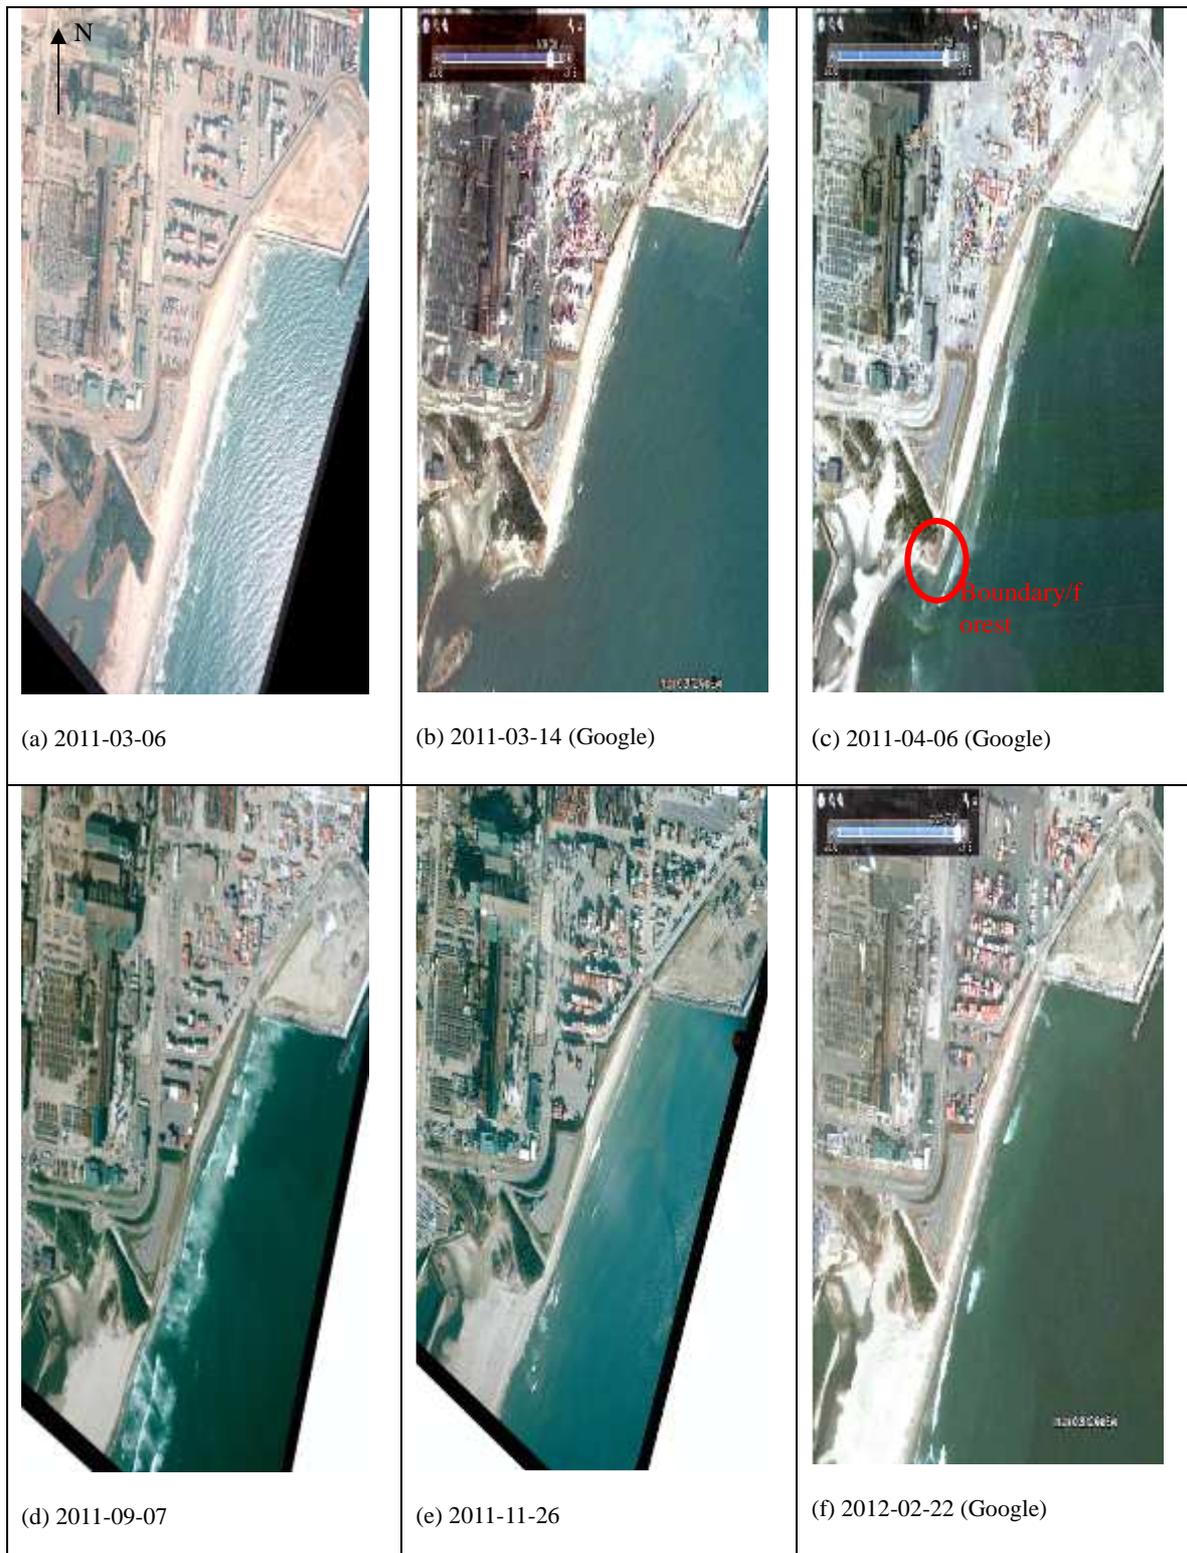
Aerial photos and satellite images were collected for zone 2 during the period of March 2011 to February 2012. The acquired images are shown in Figure 3. Zone 1 and zone 2 are separated by a forest area as shown in Figure 3 (c). It can be seen that the severe erosion due to the tsunami in zone 1 stopped approximately around the forest area.

Figure 3. Aerial photos.

The collected data for the study area covers the condition before the tsunami, right after the tsunami, and during the course of recovery process until the beginning of 2012. The satellite images and the aerial photo are shown in Figure 3. Aerial photos for the study area were collected from Google Earth for the following dates, 14 March 2011 (DigiGlobe, resolution 0.6 m), 6 April 2012 (GeoEye, resolution 0.5 m), and 22 February 2012 (DigiGlobe, resolution 0.6 m). In addition, several aerial photos, captured from airplane, were acquired. These photos show the condition around the study area for the following dates, on 6 March 2011, 7 September 2011, and 26 November 2011.

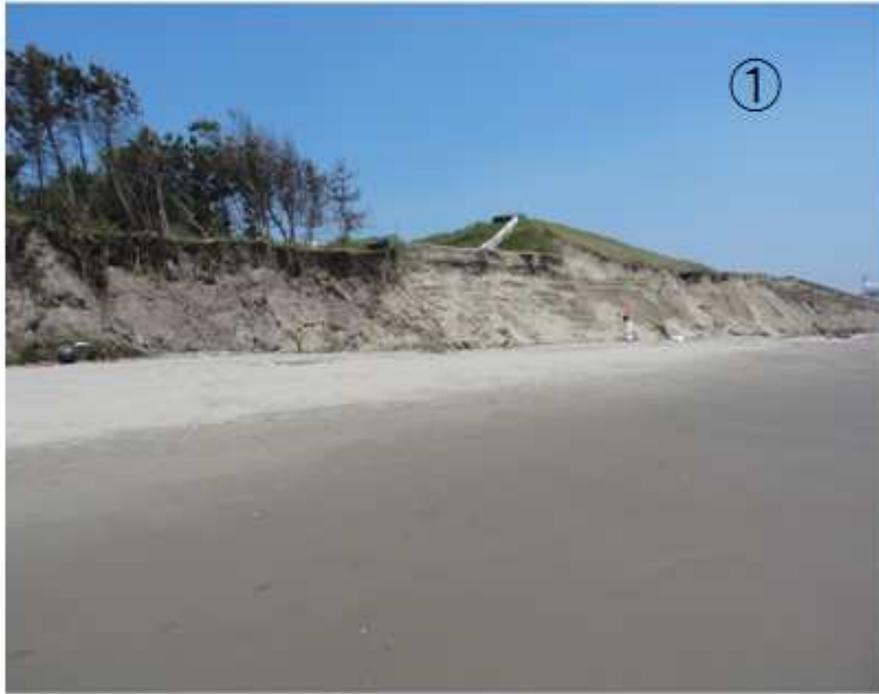
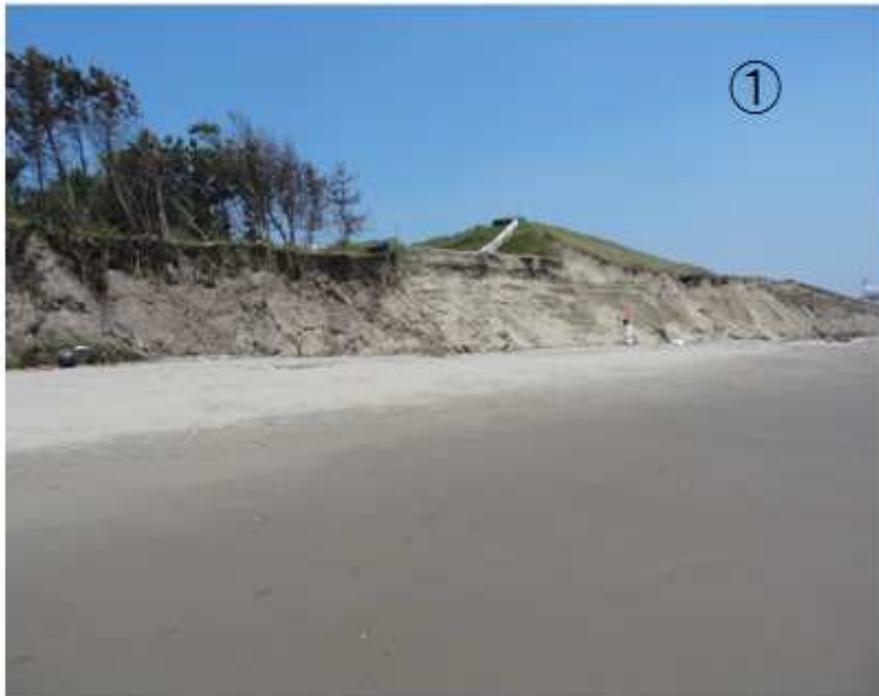
a. Location 1

b. Location 2

Figure 6. Severe erosion in zone 1.

Zone 1 and zone 2 are shown to behave differently. Zone 1 suffered the direct effect from the tsunami of 2011, showing a massive erosion and shoreline retreat after the tsunami. Figure 5 shows that the severe erosion was limited to the south part of the forest area (zone 1). On the contrary, the tsunami of 2011 only affected zone 2 slightly. There was no significant shoreline change in the north part of the forest area to the breakwater (zone 1). The severe erosion in zone 1 was quickly followed by recovery process. However, there was no recovery process in zone 2. The area was continuously eroded following the tsunami of 2011 although the long shore sediment transport moves from south to north. The photographs showing the erosion in this area are given in Figure 6 (a) and (b) showing the condition in location 1 and 2 (Figure 5), respectively.
